## **JOHNSON & KING ENGINEERS**

October 24, 2007

Re: Unitarian Universalist Fellowship of Columbia  
Review of Structural Condition

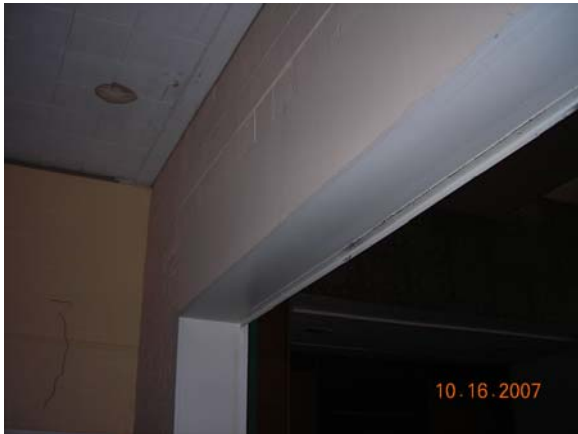
some evidence of past roof leaks was observed on ceiling tiles (Photo 1), which could have resulted in some deterioration of wood structural members or roof sheathing. Cracks are present in the exterior brick veneer on the east side of the building at the wall outside the original choir area (Photo 2). The cracks are due to settlement, which is a common occurrence on a site such as this one. The grade slopes down towards the east so that the east wall where the cracks were observed was probably built on fill which may not have been fully compacted during the original construction. The roof leaks and settlement cracks are relatively minor issues.

Photo 1      Roof Leaks

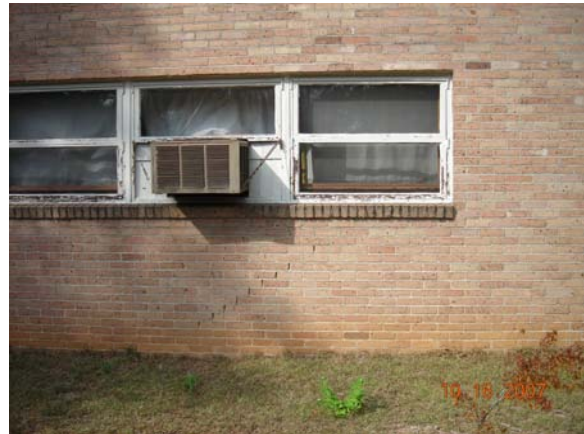
Photo 2      Veneer Cracks

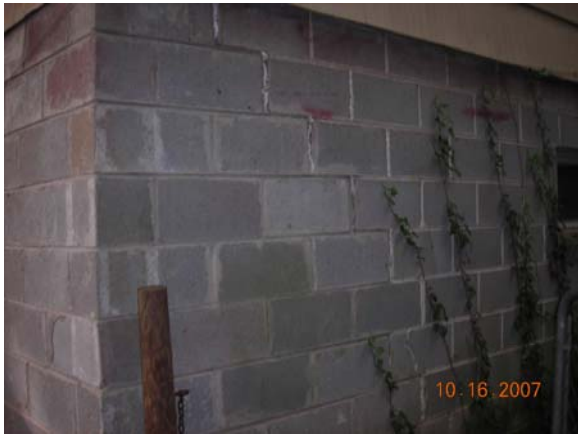
Unlike the original main building, the education building which was built using a former barracks structure is in poor structural condition. This building was added to the east side of the main building, so it has experienced significant settlement, probably due to being built on fill on the sloping site. The education wing is supported around its perimeter on a continuous concrete block foundation wall which shows evidence of severe settlement cracking (Photos 3, 4). At the floor in the classroom at the east end of the wing, it can be seen that the wall is pulling away from the floor (Photo 5). The wall has moved outwards to such an extent that the floor framing has been losing support on the wall. As an apparent result of this being recognized, additional framing and shoring posts were added at some time in the past to provide additional support for the floor adjacent to the foundation wall (Photo 6). The interior floor framing of the education wing is supported on steel shoring posts (Photo 7) instead of concrete block piers as is more typical in crawl space construction. Posts such as these are generally considered to be temporary, rather than permanent, structural supports. In addition, these posts appear to bear on concrete blocks (Photo 8), rather than on concrete footings. Again, this type of construction is usually considered temporary rather than permanent.

The settlement problems in the exterior foundation wall and the temporary nature of the interior supports are serious deficiencies that could result in an unsafe condition. As long as this building remains in use, the foundation wall and interior support posts should be frequently inspected by the church to ensure that no movement has occurred to compromise the support of the structure.

Photo 3      Foundation Wall Cracks

1. Due to the amount of wood construction present in the church, regular termite inspections should be performed.
2. The foundations of the education wing should be regularly monitored by church personnel. No recommendations are made for permanent repairs to the foundations since this is a very poor quality structure and it is understood that the master plan contemplates the eventual replacement of this wing. The education wing should be demolished as soon as practical based on the master plan.

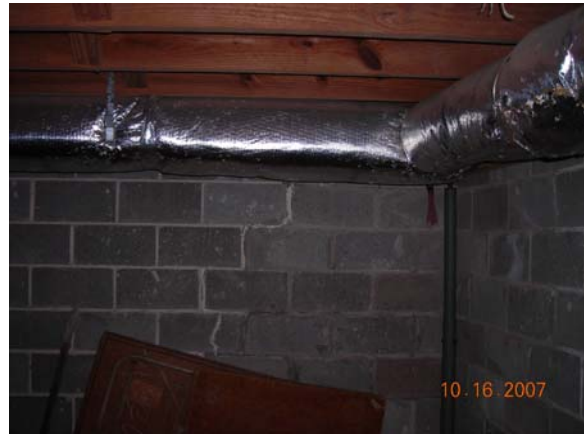
Photo 4      Foundation Wall Cracks

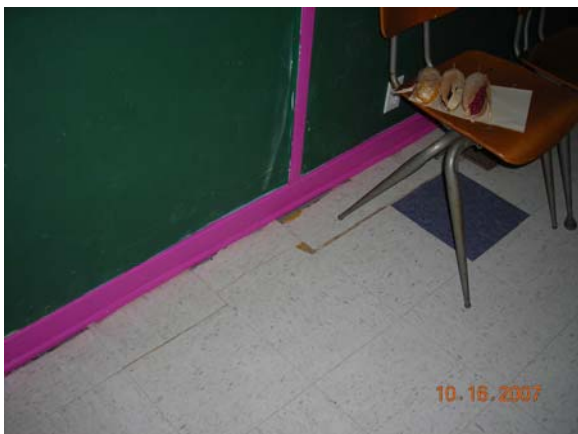
Photo 5      Wall Pulled Away

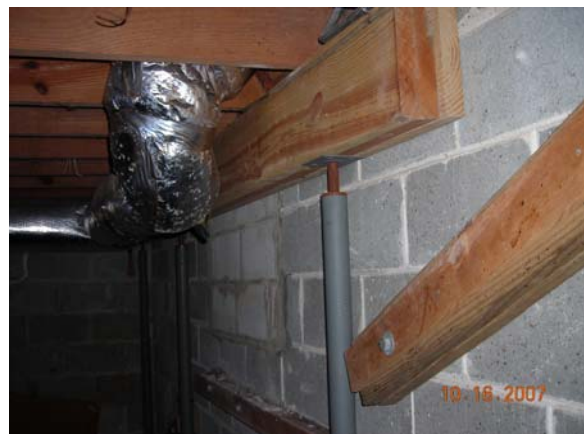
Photo 6      Shoring Added

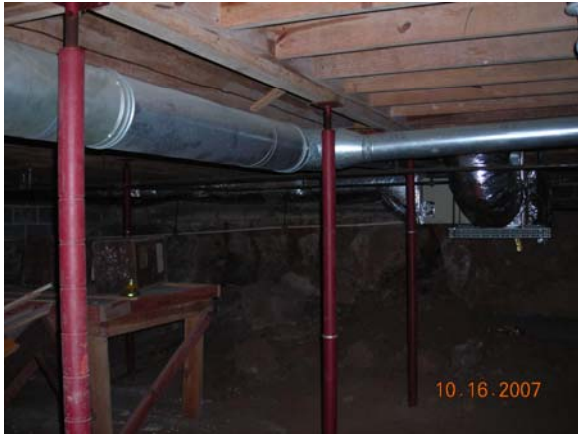
Photo 7 Post Shores

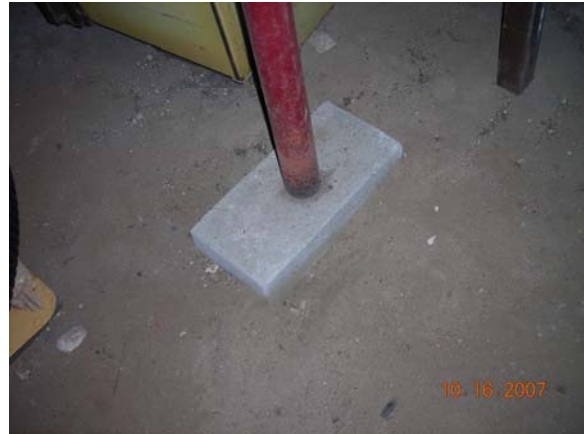
Photo 8 Concrete Block Footing
